FUNDÃO MINE TAILINGS DAM FAILURE

This case study on the Fundão Mine tailings dam failure, has been prepared solely by GDS following its review and interpretation of the publicly available technical report. This case study briefly summarises some of the many geotechnical engineering findings reported by the panel. Specifically, it focuses on aspects of the advanced laboratory testing programme conducted during the investigation, which employed an advanced cyclic direct simple shear apparatus designed and manufactured by GDS Instruments.

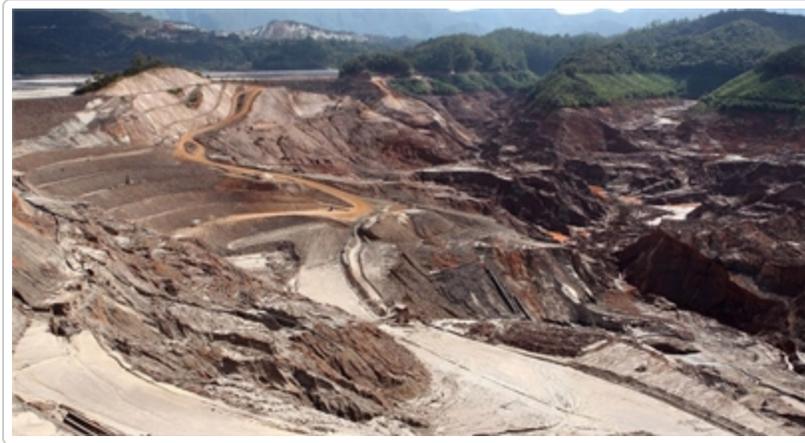
Figure 1: The Fundão Tailings Dam on the 7th of July, 2016, approximately eight months after failure occurred.

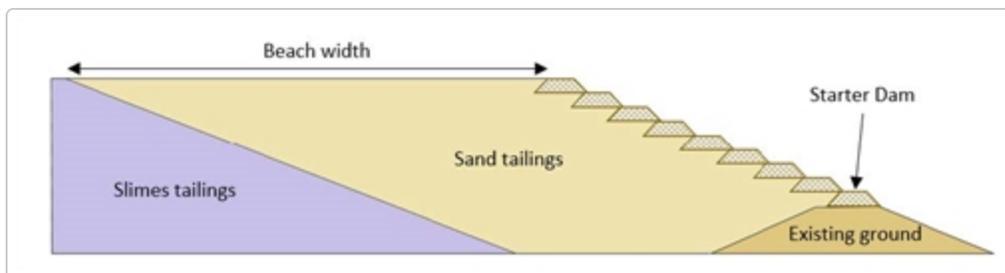
This concept aimed to progressively stack the sands behind a Starter Dam, with the slimes retained behind the sand stack, and the Starter Dam raised on top of the sands using upstream-style construction. A critical condition of this design was to maintain adequate drainage within the loose, uncompacted sands, such that the sands remained unsaturated and did not become susceptible to static liquefaction. This condition was to be met through (i) construction of a high-capacity drainage system beneath the Starter Dam; (ii) construction of concrete galleries (2 m diameter conduits) beneath the left and right Dam abutments to convey upstream surface water inflow downstream of the Dam; (iii) separation of the slimes from the sands during tailings deposition by maintaining a 200 m sand beach width from the Dam crest, such that downward drainage in the sands was not impeded.

Figure 2: Generalised schematic illustrating the 'drained stack' concept.
