MOUNT POLLEY MINE TAILINGS STORAGE FACILITY EMBANKMENT BREACH

INTRODUCTION

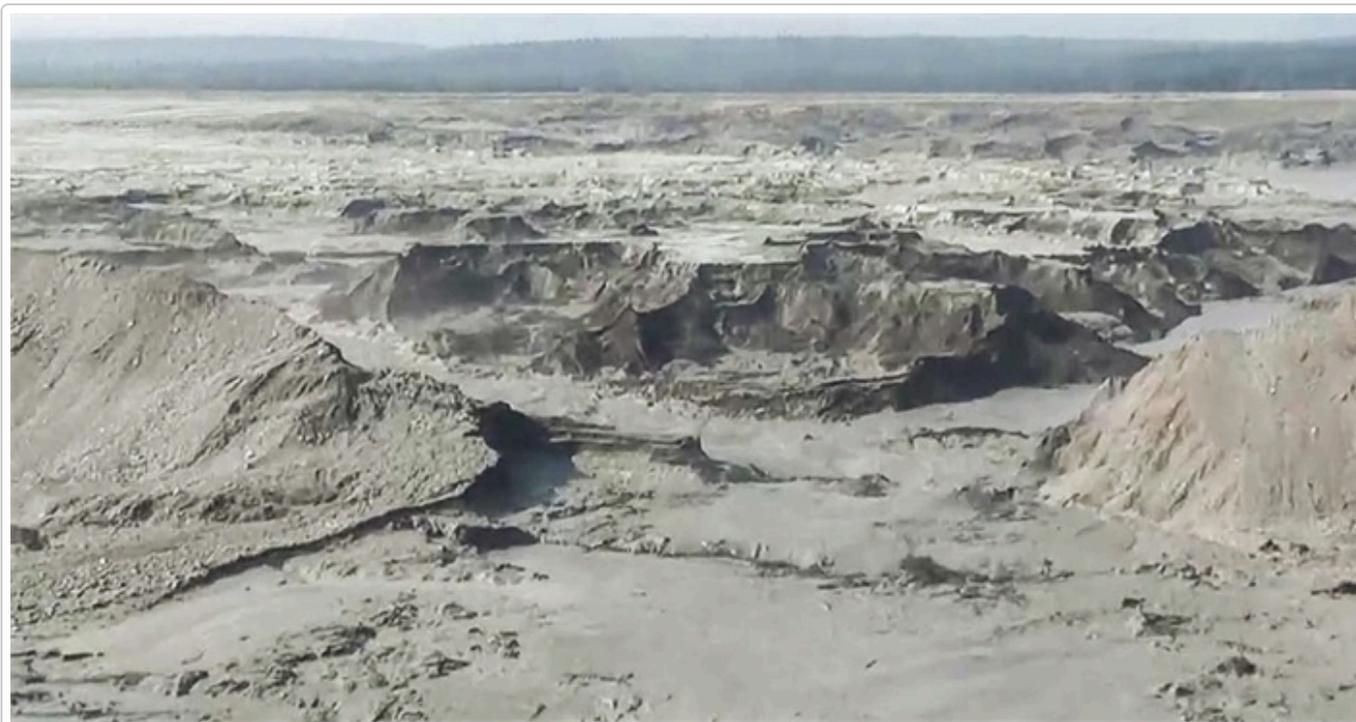
Figure 1: Photo of the Mount Polley Mine Tailings Storage Facility breach, looking upstream.
Source: Morgenstern et al. (2015). Used with permission from Province of British Columbia.

Surface investigations provided direct evidence that shear failure of foundation soil beneath the Embankment was the primary cause of the breach. Subsurface investigations then inferred the location of the shear failure zone to be within the Upper GLU unit, at an elevation approximately 10 m below the Embankment base.

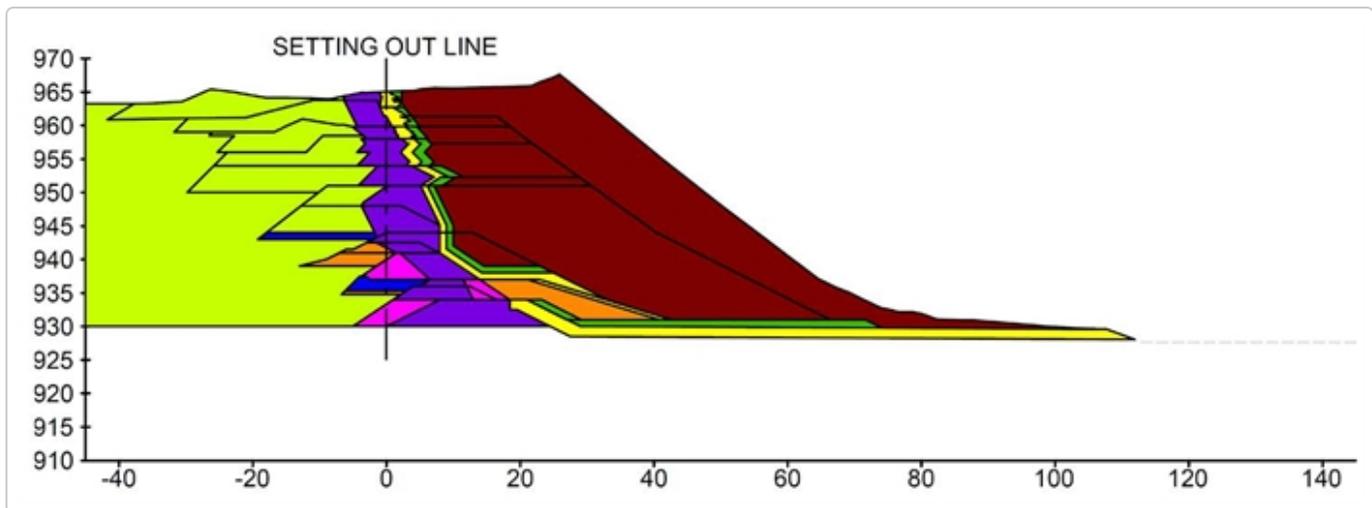
The Embankment design consisted of an impervious core, with filter, transition, and rockfill zones on the downstream side of core. Upstream of the core, a fill zone was to consist of rockfill and/or tailings. The Embankment was also initially designed to be constructed using a modified centreline configuration however, a number of Embankment raises ultimately utilised an upstream-style construction configuration.

Figure 2: Schematic section of the Embankment prior to failure occurring.
 Source: Morgenstern et al. (2015). Used with permission from Province of British Columbia.

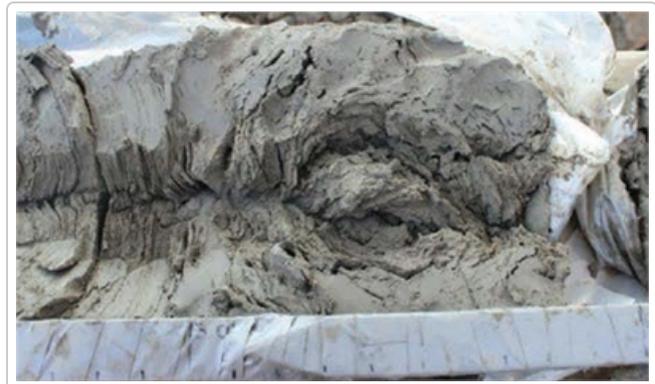
Figure 3: Photo of Upper GLU soil sampled from within the breach area, showing contorted and folded laminations.

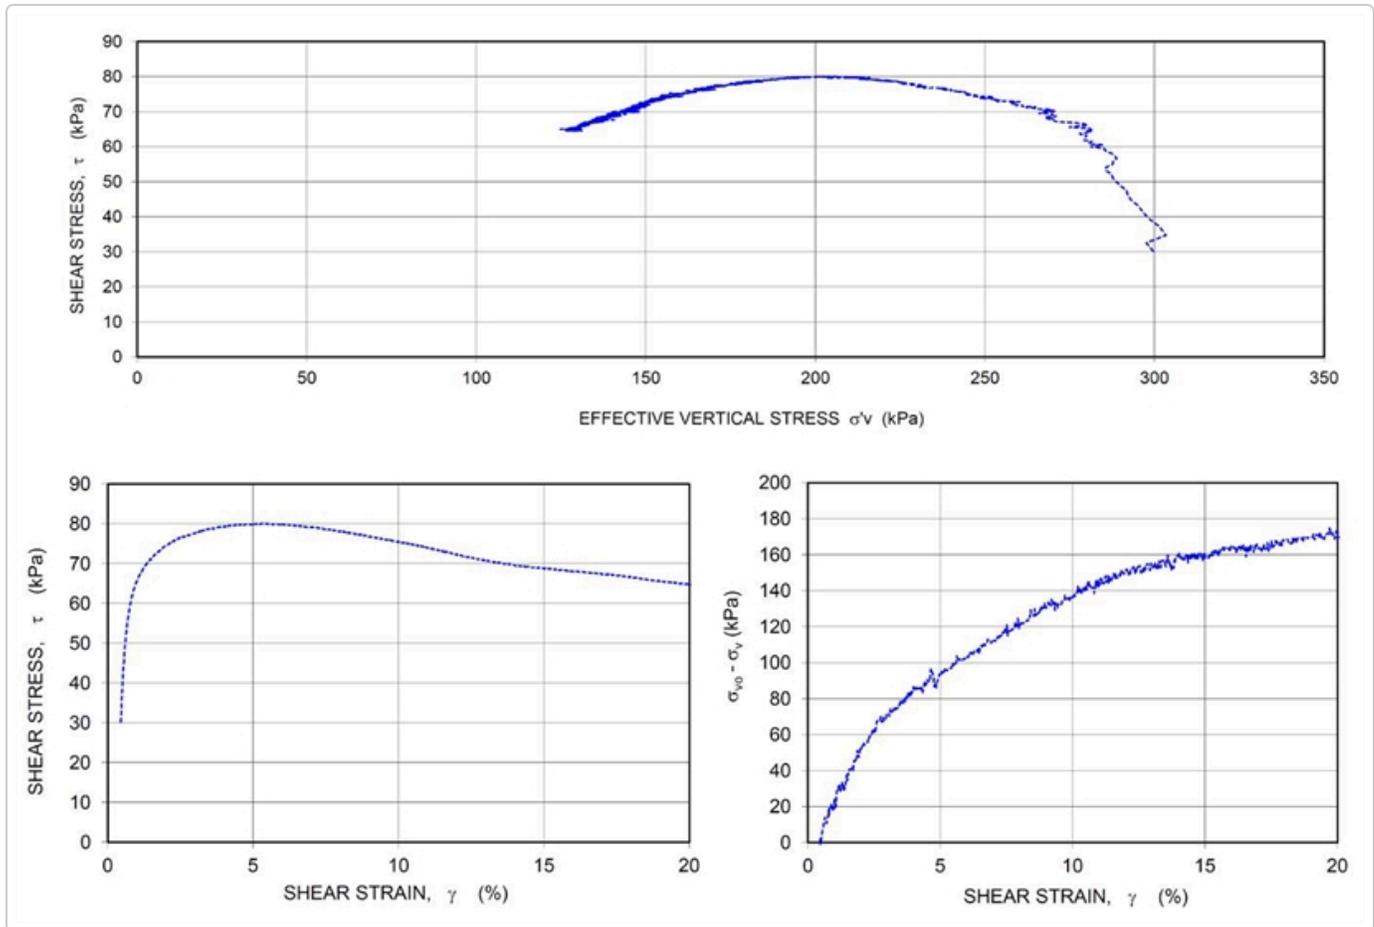
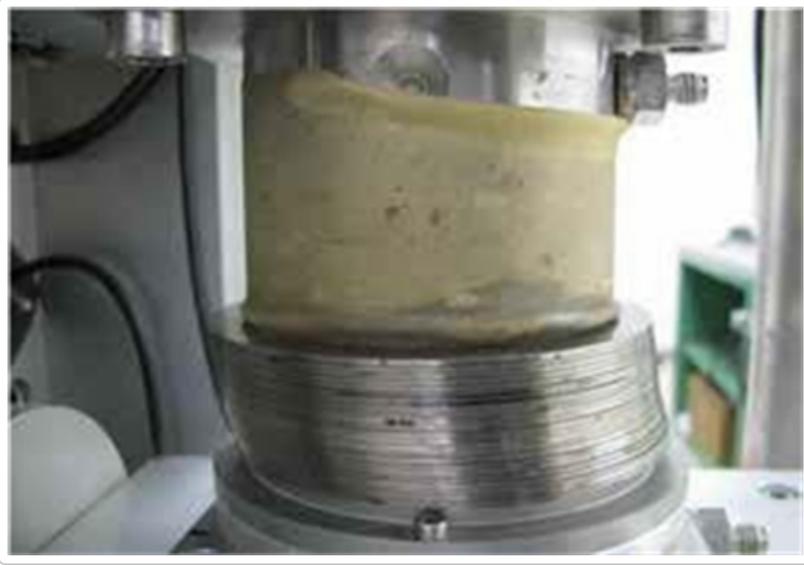
Data gained from the direct simple shear tests produced estimations of peak undrained strength ratios (i.e., peak shear stress divided by vertical effective consolidation stress) in the range of 0.20 to 0.28, depending on the consolidation conditions. In addition, the test specimens generally demonstrated strain softening behaviour (i.e., a reduction in shear stress) once the soil was strained beyond the peak shear stress.

Figure 6: Direct simple shear response and photos of an Upper GLU soil specimen tested under constant volume conditions within a GDS Electromechanical Dynamic Cyclic Simple Shear (EMDCSS) device.

- The direct simple shear testing also highlighted the strain softening tendency of the Upper GLU soils. This demonstrated that the resistance of the soil to applied loading would decrease as shear deformations progressed, and helped to explain why the Embankment failure occurred in a sudden manner.

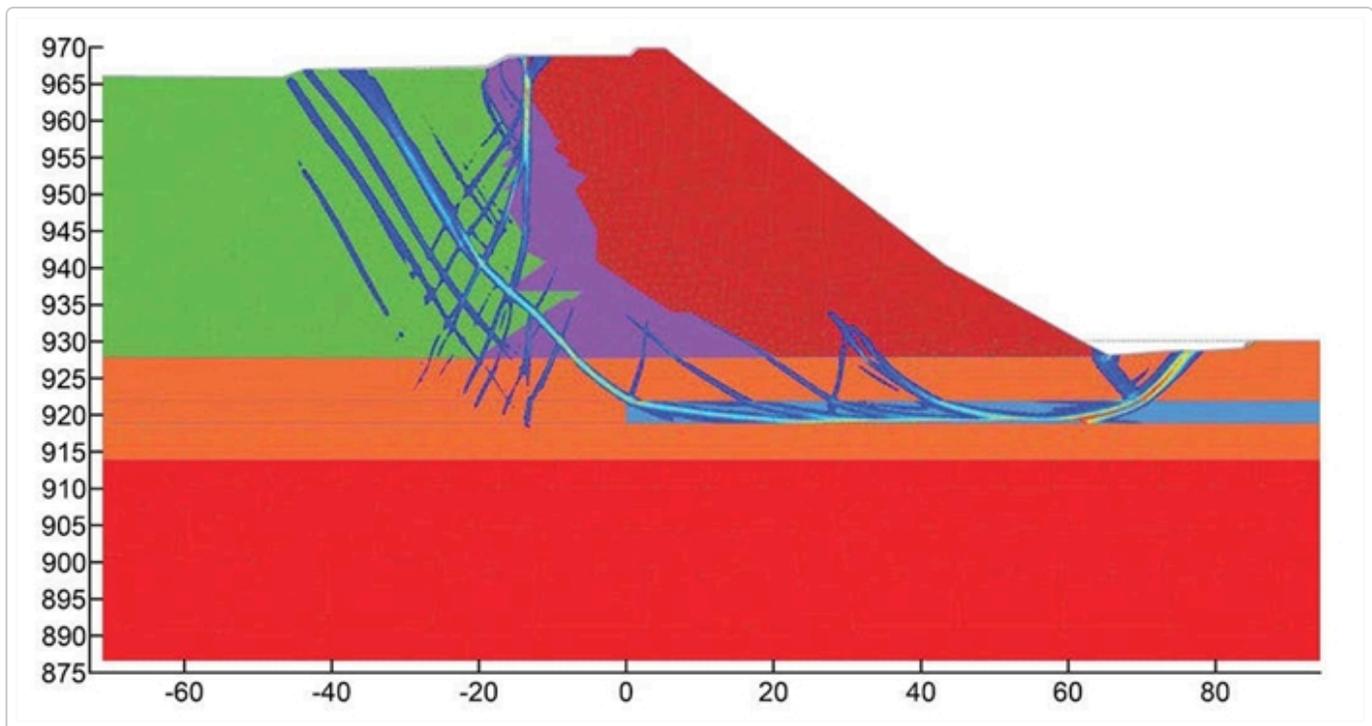
- The direct simple shear testing provided the Panel with undrained strength parameters for the Upper GLU soils that were critical to the investigation. These parameters, subsequently adopted within limit equilibrium and deformation analyses that examined Embankment stability, helped the Panel to conclude that undrained failure of the Upper GLU deposit was the specific mechanism that caused the breach to occur.

Figure 9: 2D PLAXIS analysis conducted by the Panel, showing the Embankment deformation locations estimated at failure.
